CITY OF CROOKSTON
 EXPENDITURES REPORT
 AS OF: JUNE 30TH, 2025

RE: City of Crookston
Indoor Aquatic Center Building
Structural Assessment and
Recommendations
SEH No. CROOK 165726 42.10

RESOLUTION REGARDING THE AUTHORIZATION TO MAKE REPAIRS TO THE CROOKSTON COMMUNITY SWIMMING POOL

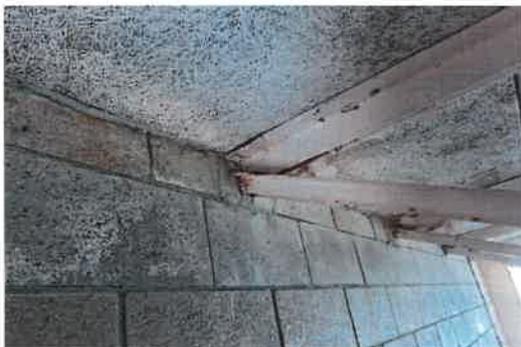
Roof bar joist framing appears to be in generally fair condition except at the perimeter of the building and in the vicinity of the roof step where surface rust is extensive. At the perimeter walls, light surface rust is present on nearly all joist seats and on the roof deck support angles and bridging angles on walls parallel to the joists.

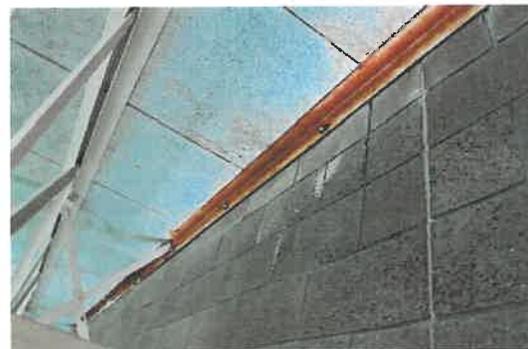
Related to the joist framing, the end wall angle framing also exhibits significant surface corrosion, also without evidence of scaling or section loss in the areas directly observed. The bearing angle immediately below the fiber cement roof panels is more corroded than the angles lower on the wall that serve as connection point for joist bridging, but all exhibit at least some surface

rust. We recommend that the repair project include removing and replacing connection angles at each endwall and cleaning rust from connecting joist bridging. It may be more cost effective to entirely replace the angles with new material rather than sandblasting and recoating them. We also recommend replacing all the wall anchors on each endwall with stainless steel anchor rods and hardware for better durability.

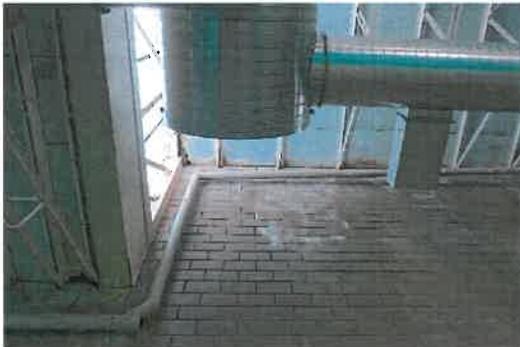
As with the roof bar joists, the condition of the roof fiber cement board roof panels (commonly identified according to the common trade name Tectum) is fair throughout most of the building but poor adjacent to the perimeter walls and the roof step. These fiber cement board panels are extensively stained at roof edges and near the roof step and in multiple locations they are deteriorated and beginning to fall to the pool deck. During observations a small amount of debris was found along the north wall of the diving pool area.

The worst deterioration observed is generally on the north wall where the roof slopes to drains and overflow scuppers. This location suggests that a past roof leak could have been a contributing factor in the deterioration. However, there is also significant staining and some deterioration in panels along the south wall at the higher side of the natatorium. The occurrence of staining and deterioration, to some degree, along all perimeter walls indicates that the condensation issue described above is more likely the primary cause of the issue.

The high priority repair recommended for the roof deck panels is to install temporary support measures between bar joists at the severely weakened panels (those with falling material, cracking through fibers, or severe moisture staining) to protect against falling debris hazards and to support dead loads and snow loads until a more comprehensive repair can be implemented. This temporary support might be accomplished by placing fire treated plywood flush to the bar joist top chords and securing it to the bar joist top chord with some form of mechanical clamp.

Following temporary stabilization measures, replacement of the deteriorated panels is recommended. Selective replacement of the fiber cement panels from below is not practical, so repair measures would require removing or pulling back the roof from parapets on all sides of the natatorium space. Removal and replacement of the entire panel length nearest to and parallel to each bearing wall will be required for cleaning and recoating bar joists as well as eliminating the moisture damaged material. Along the end walls where tectum panels are supported by a steel angle there is less apparent moisture damage, so selective removal and replacement is recommended on these walls.

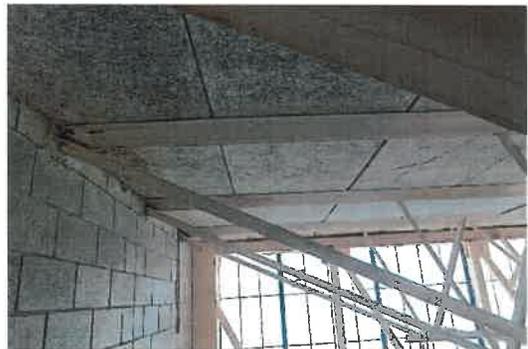
There is evidence of corrosion on the tube steel truss at the roof step with visible scaling on top of the truss and streaking on truss web members. The extent of corrosion is not clear because of limited accessibility and because of a plaster bulkhead built around the bottom chord of the truss. The plaster bulkhead exhibits some cracks and staining which appear to be related to

moisture intrusion and/or condensation. The bar joist immediately adjacent to the roof truss at the low roof has significantly more surface rust than the other low roof trusses, suggesting that condensation along the roof step and the tube steel truss has been ongoing. The north end of the truss bearing in the wall is in poor condition, with the plaster soffit deteriorating from moisture exposure cracks and efflorescence visible in the masonry wall below bearing.

As a priority repair item, we recommend repair and repointing of masonry below truss bearing (see further discussion in the following section). We also recommend selectively removing a section of plaster soffit at each end of the truss and at one location near the middle to allow visual observation of the truss bottom chord and the web member connections to the bottom chord to see if corrosion is hidden behind the finish materials.

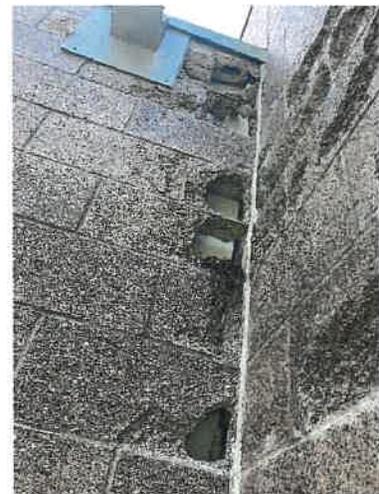
Perimeter masonry veneer varies significantly in condition by type of construction and location. The worst conditions are found in original concrete masonry veneer, which exhibits severe deterioration in several locations around the building including above the main entry, above and beside the pool equipment room and maintenance room at the north side of the building. Although the deterioration in these locations is severe, the failing blocks make up a small percentage of the building surface. Other veneer in these areas is not failing yet but exhibits efflorescence and "spider cracking" suggesting the start of further deterioration.

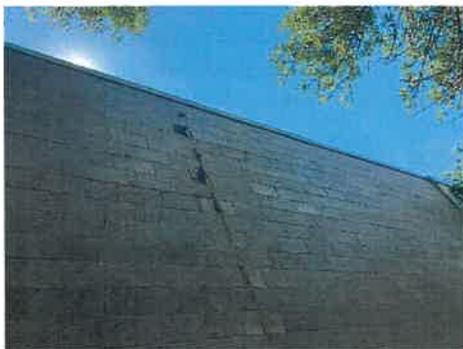
Other portions of the building (west side of entry, mechanical room, south wall of natatorium above lower roof) had insulated metal panel cladding added outside the original masonry veneer. When making observations on site it was not practical to remove panels to observe the condition of backup materials and City staff were not equipped with tools to remove and reinstall panels. However, from observations of the metal panels above the east side of the entry, there appears to be some veneer separation occurring behind the panels, perhaps similar to separation that is occurring on the south facing wall.

Priority repairs will include removal and replacement of spalled face shells and veneer blocks above the front entry to avoid falling debris hazards. This might be accomplished by securing a protection board, but considering the weak condition at the masonry surface, outright replacement is likely the better option. Similarly, the failing veneer blocks on the inside corner of the maintenance room (north side of building), broken blocks near a control joint on the west wall, and spalled veneer blocks above the pool equipment room and maintenance room should be replaced to eliminate gaps

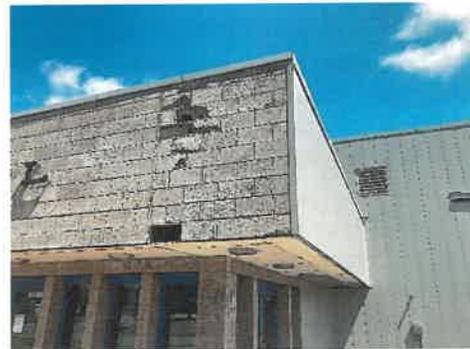
Failing veneer and face blocks above the front entry suggest that indoor humidity is getting into the unheated soffit space. Therefore, as part of comprehensive repairs we recommend removing the existing soffit and lighting, installing a new vapor barrier above the glazed walls (to be determined whether from inside or outside), and replacing the soffit. In conjunction with this work the surface rust on the lintel beams should be cleaned and a new coating suitable for exterior service should be applied.

A comprehensive solution to the cladding issues will be dependent on the further investigation and will require analysis of wall systems to assess vapor drive and dew point within the wall system as well as potential cold bridges and sources of moisture intrusion. We expect that a solution will involve a new insulated cladding system outside of the exterior veneer, but wall and parapet details and vapor barriers will need to be carefully considered to avoid creating potential new problems while resolving the current issues.

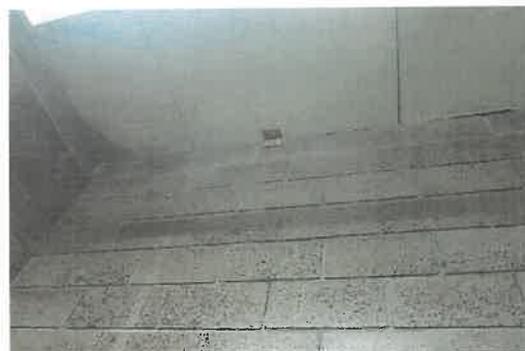
The pool equipment and maintenance office on the north side of the building have walls exhibiting moisture staining, efflorescence, and mold growth. The high humidity levels in this area and likely thermal bridging are thought to contribute to these conditions. However, the exposed hollowcore roof system in this area appears to be in good condition. There is mild to moderate surface rust present on framing angles connecting the hollowcore plank to exterior walls. This condition is not structurally significant and can be addressed with later repairs. It is

expected that the issues observed in these rooms will be addressed by better controlling humidity through mechanical systems and updates to the performance of the exterior wall cladding systems and roof insulation. A perimeter sealant or coating system may be recommended to limit water vapor into the plank.
